1N-23
3802
NASA Contractor Report 4586

Analysis of Selected Materials Flown on Interior Locations of the Long Duration Exposure Facility

H. A. Smith, K. M. Nelson, D. Eash, and H. G. Pippin

Contracts NAS1-18224 and NAS1-19247
Prepared for Langley Research Center

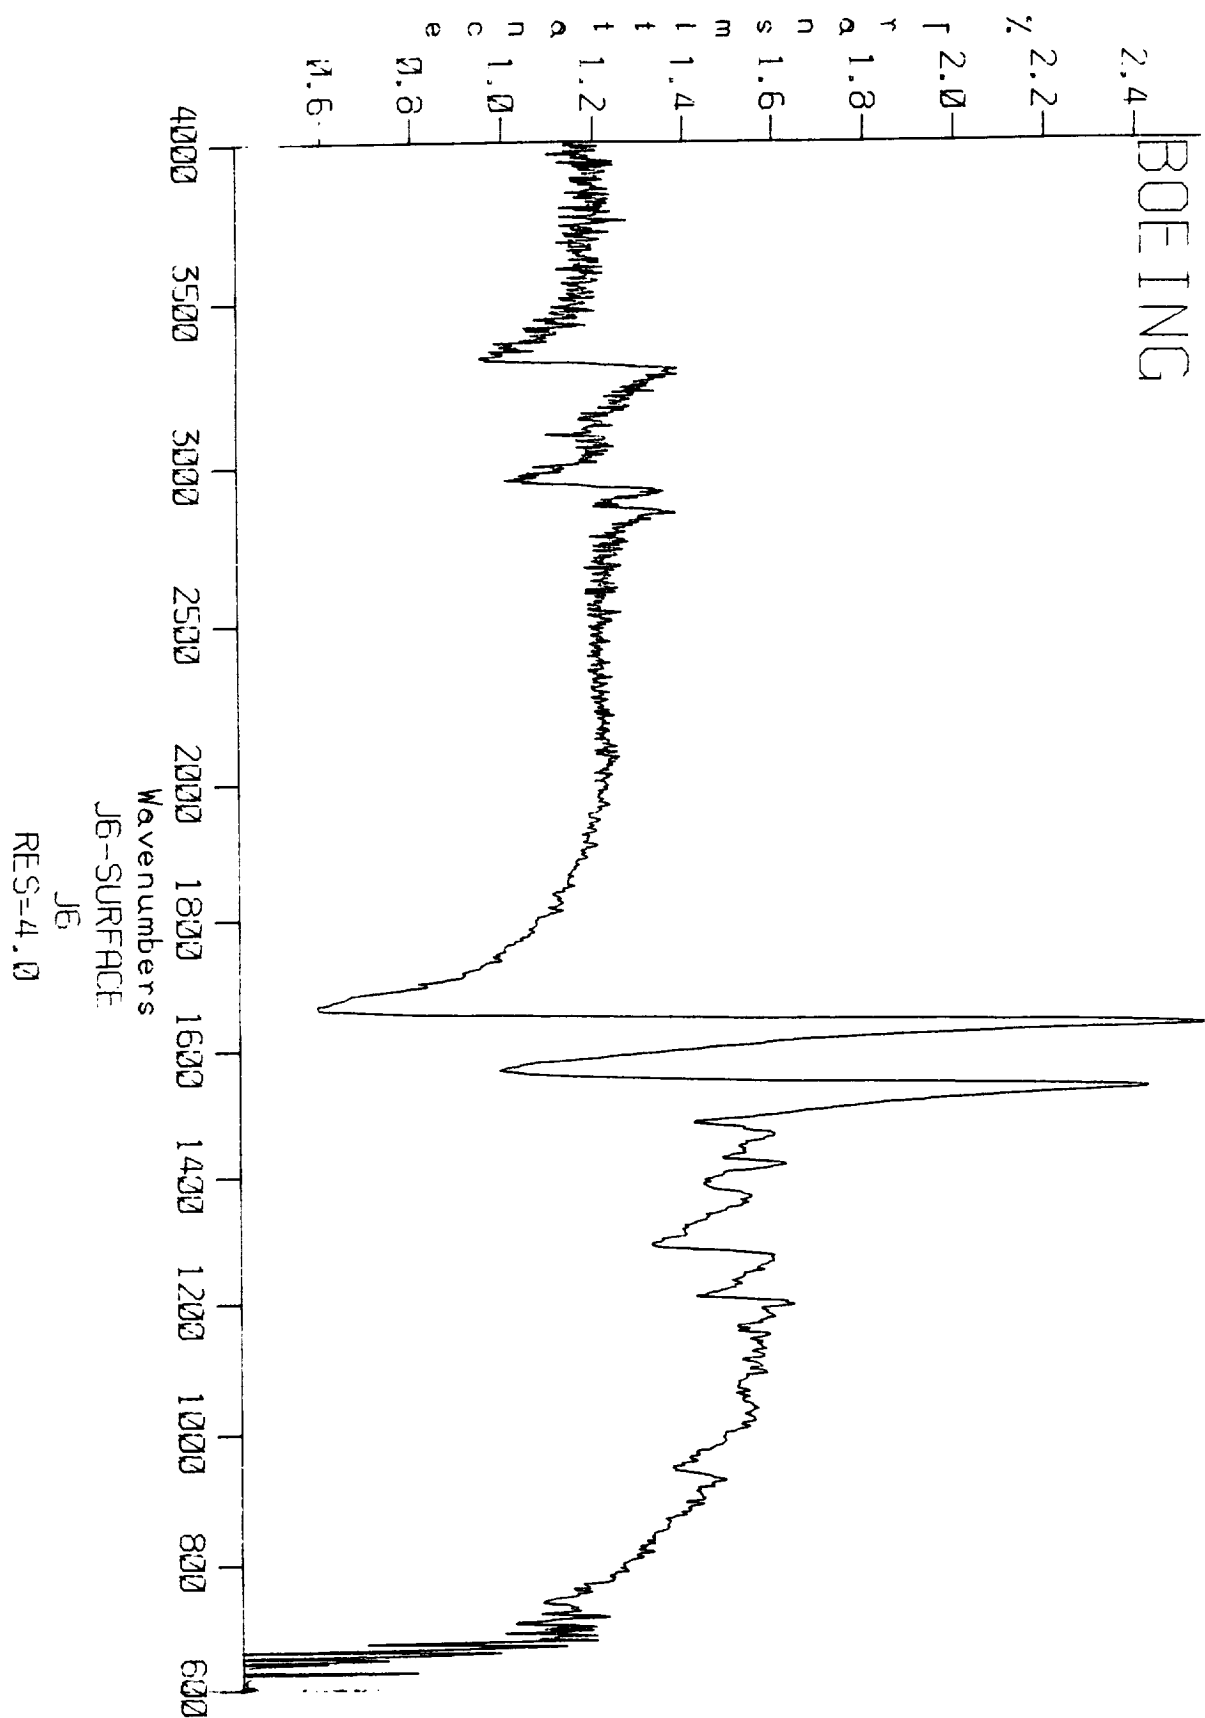
Figure 37. IR transmission spectrum of surface of wire harness bundle nylon grommet J6.

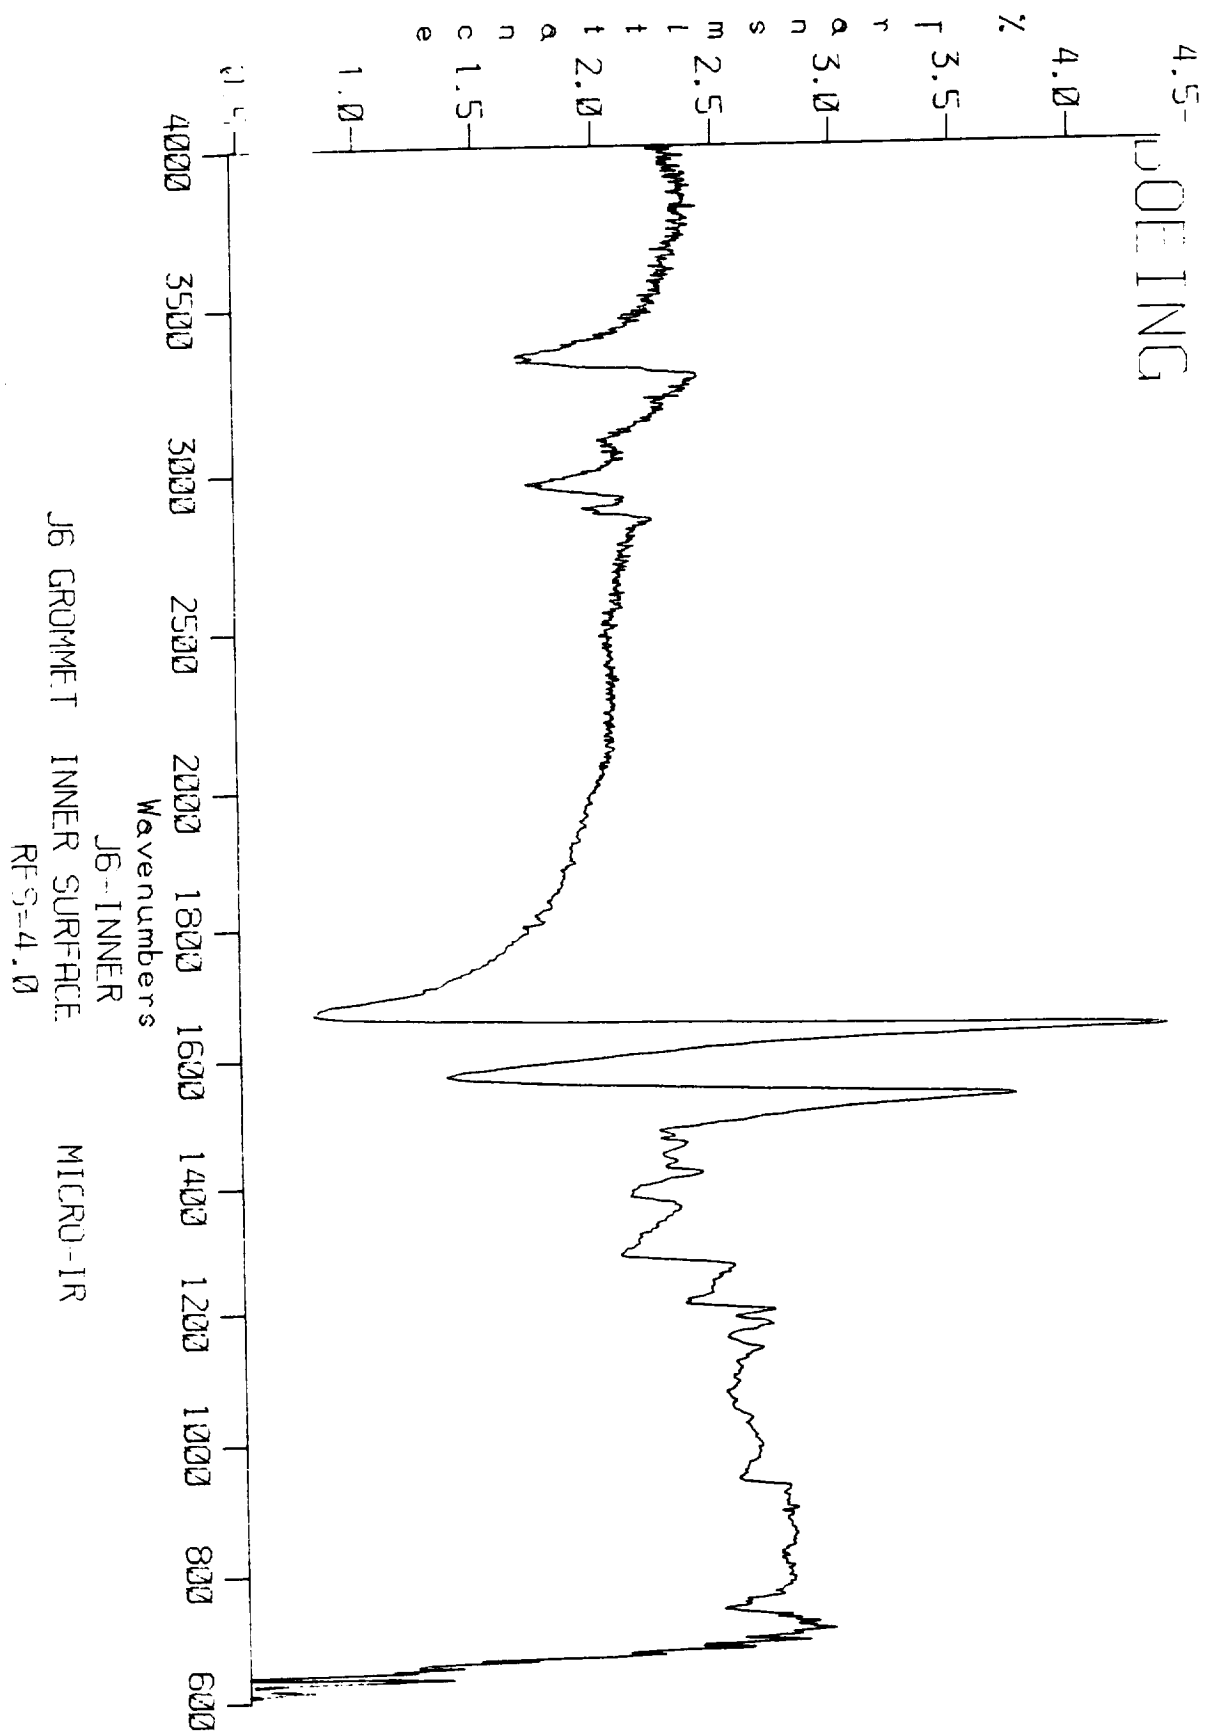
Figure 38. IR transmission spectrum of bulk material from wire harness bundle nylon grommet J6.

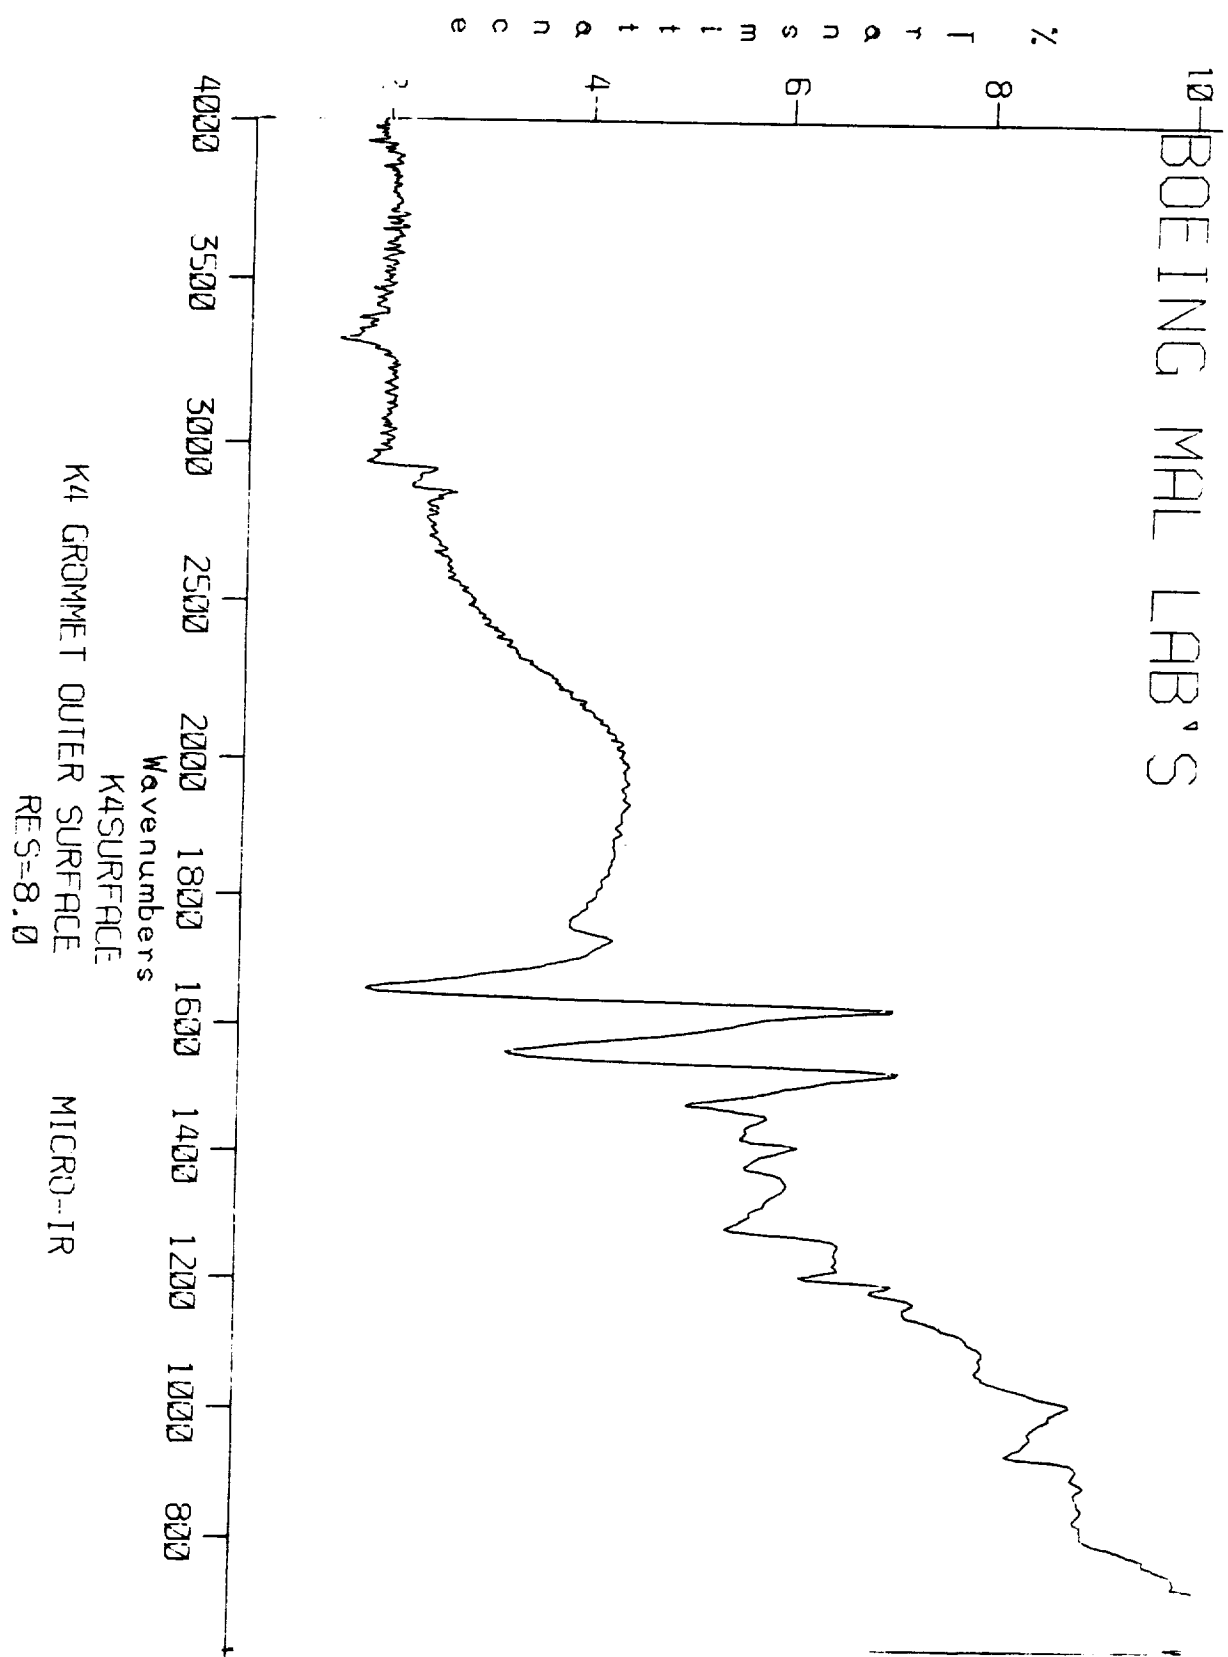
Figure 39. IR transmission spectrum of surface of wire harness bundle nylon grommet K4.

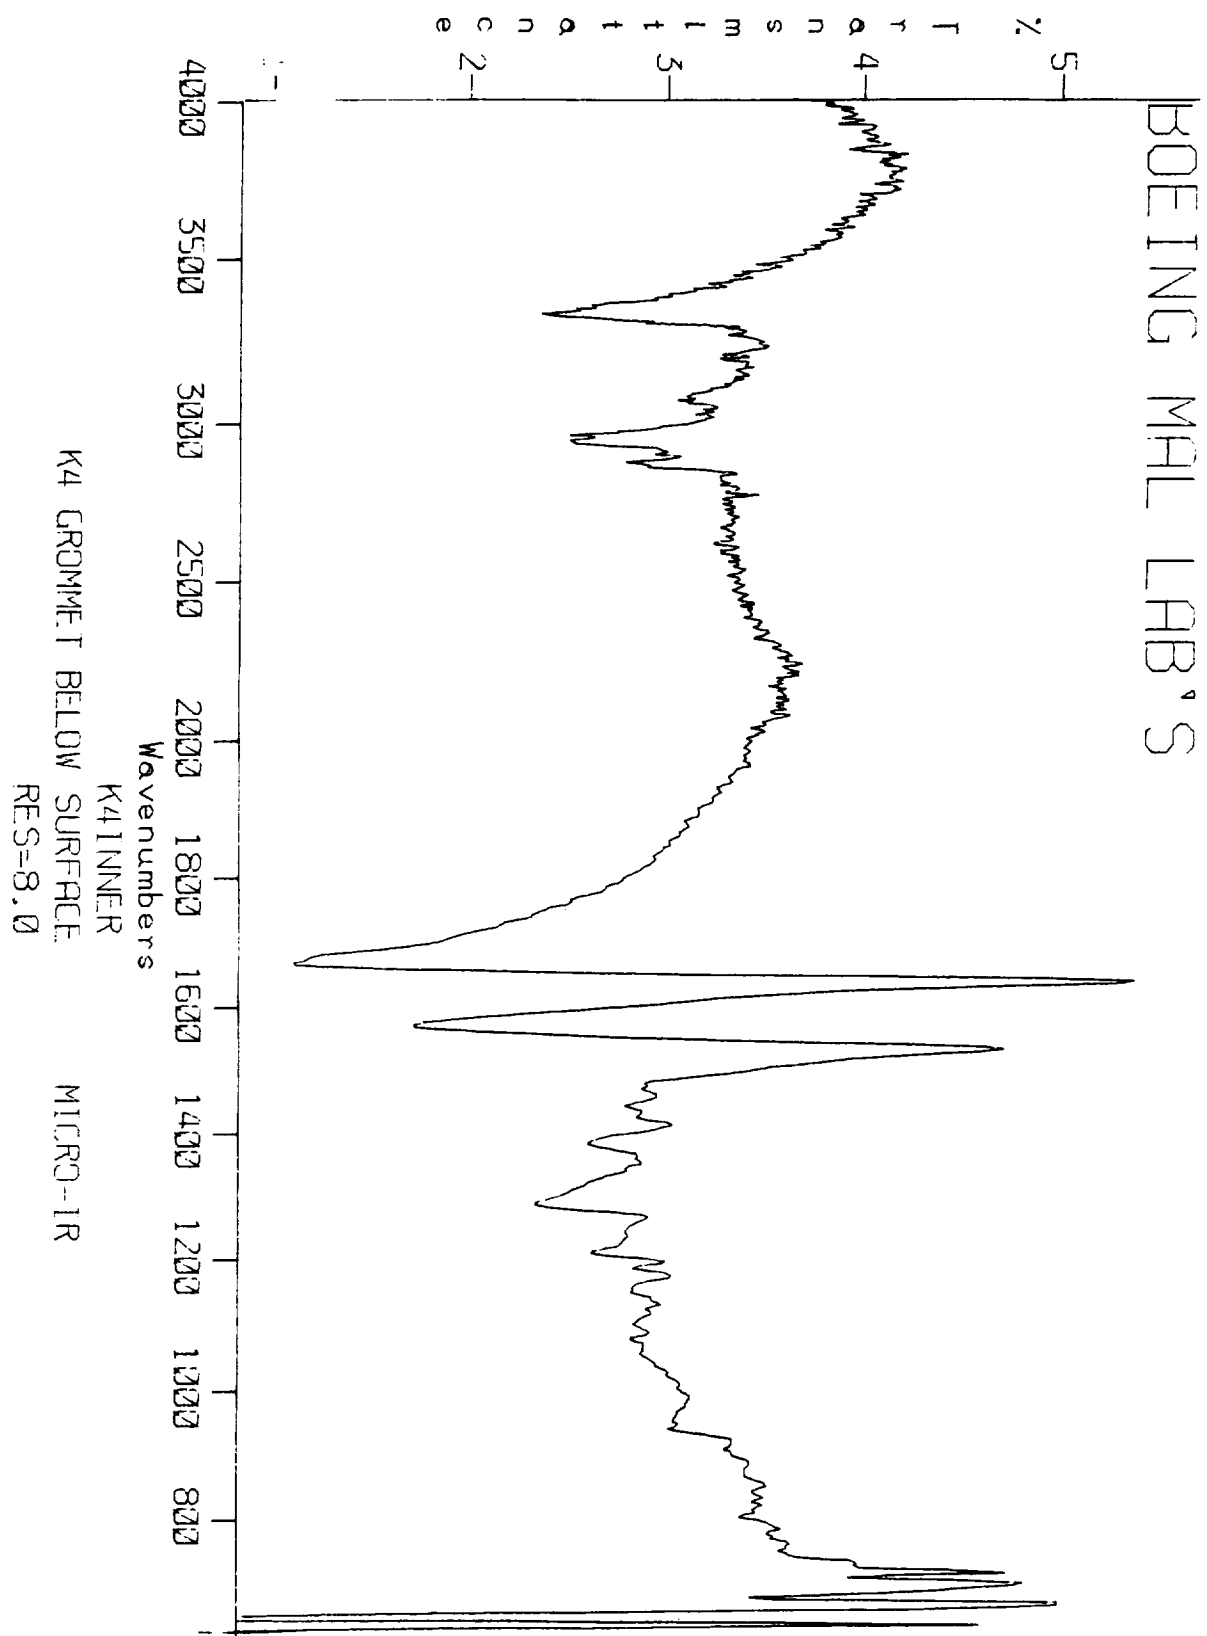
Figure 40. IR transmission spectrum of bulk material from wire harness bundle nylon grommet K4.

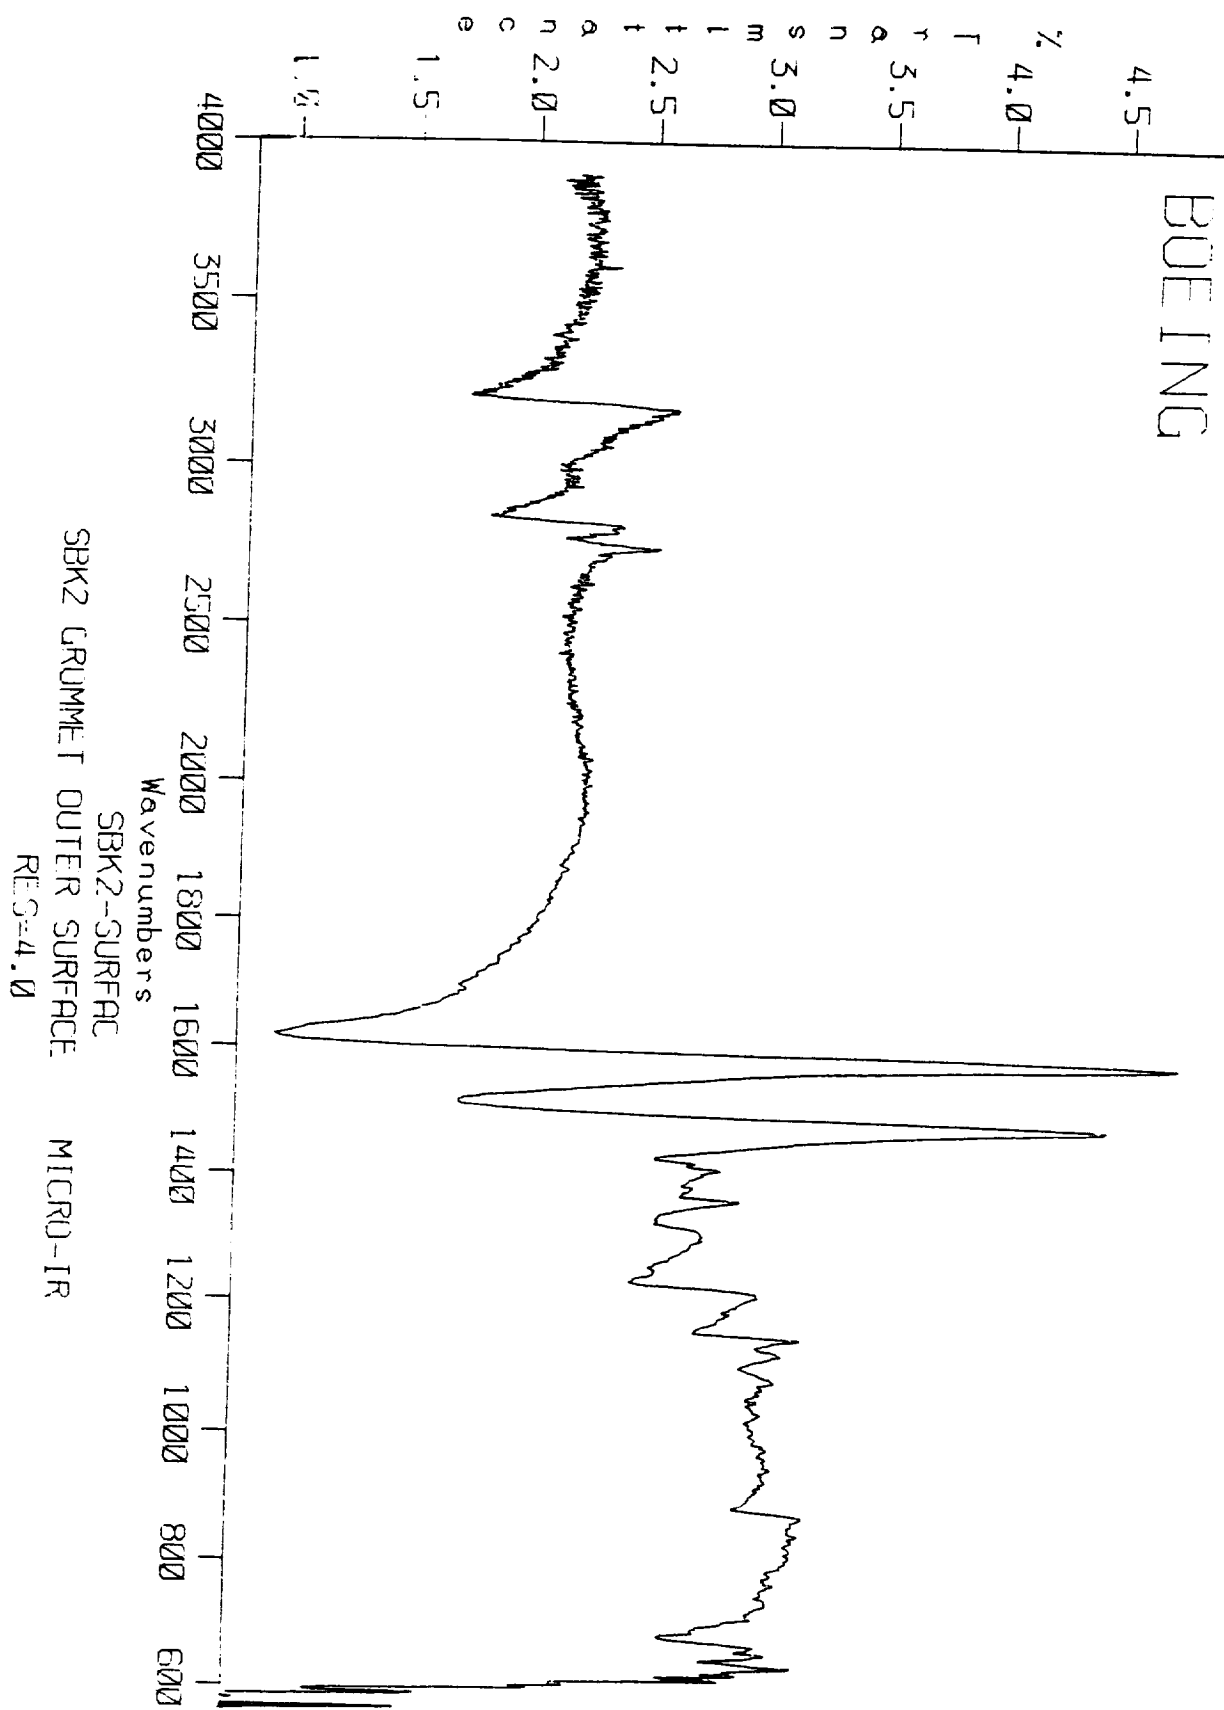
Figure 41. IR transmission spectrum of surface of wire harness bundle nylon grommet SBK2.

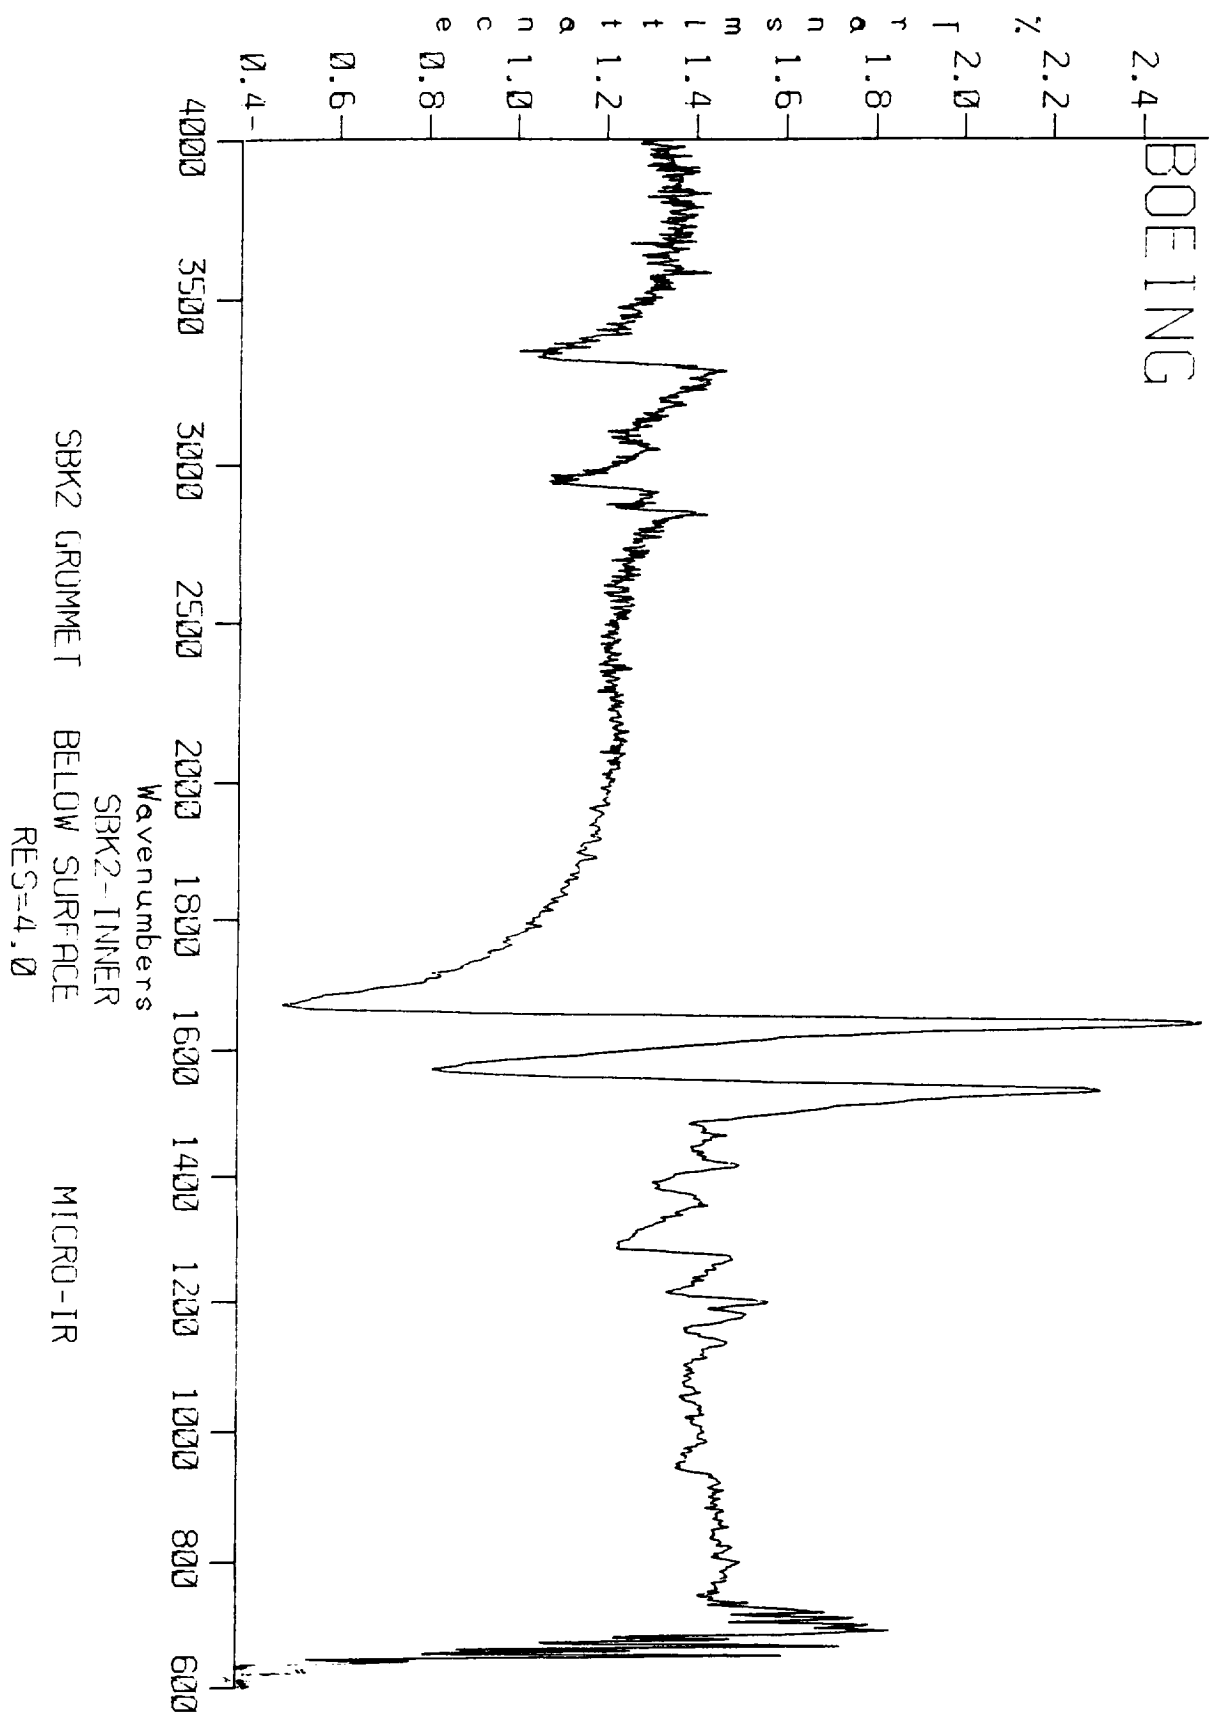
Figure 42. IR transmission spectrum of bulk material from wire harness bundle nylon grommet SBK2.
